# DS Marine Surveys

## Condition and Valuation Survey Report #

**Builder:** C&C

**Model/Type:** 37R

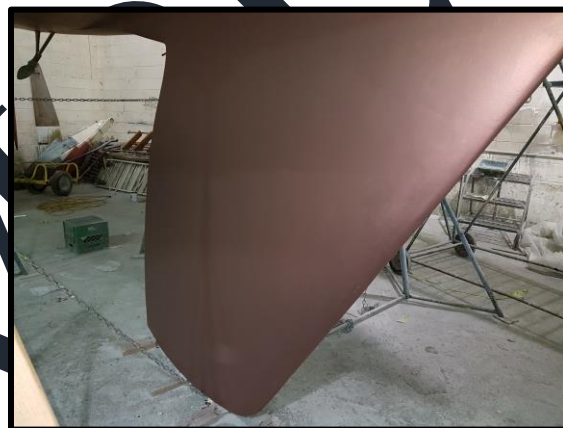
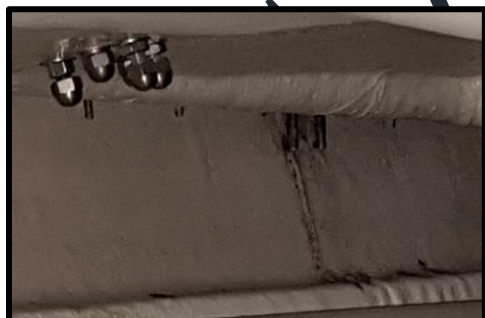
**See Item 1**

**Hull to Deck Joint:** Overlapped joint is through bolted, caulked and capped with an aluminum toe rail. No working of the joint was seen. A small leak at 2 bolts on the starboard aft area was noted.

- 1-Re-bed leaking hull to deck joint bolts.
- 2-Suggest to re-bed deck fittings on areas noted on page 5
- 3-Inspect and repair as necessary, kink in mast shroud.

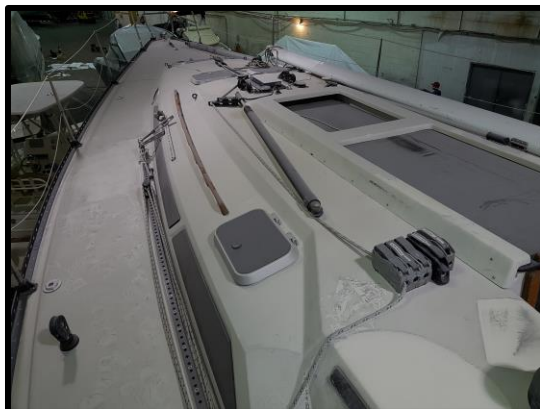
**See Item 2**

**Moisture Levels:** Low with moderate levels registered at the mast partner flange, the starboard line clutches and the starboard grab rail.

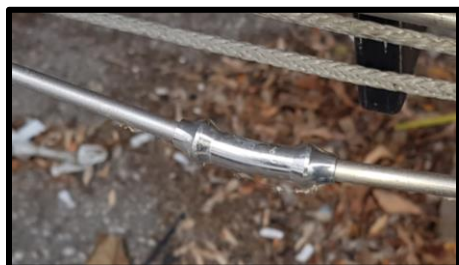
**See Item 3**

**Standing Rigging:** Assumed 1X19 stainless steel rod and fittings. All appear to be in serviceable condition with no visible parted wire yarns. All fittings are compression, inspected where accessible and appear serviceable as well. A kink was noted in a mast supporting shroud.

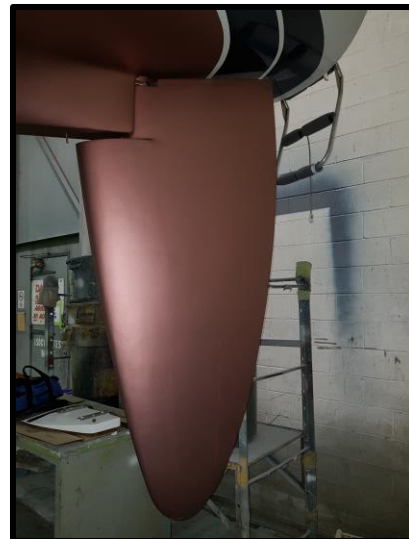
**See Item 4**

**Rudder:** FRP spade rudder is in questionable condition showing elevated moisture levels in the lower areas. Soundings show no apparent issues.

4-Recommend to drain rudder at each haul out. Monitor condition and if necessary repair as required.

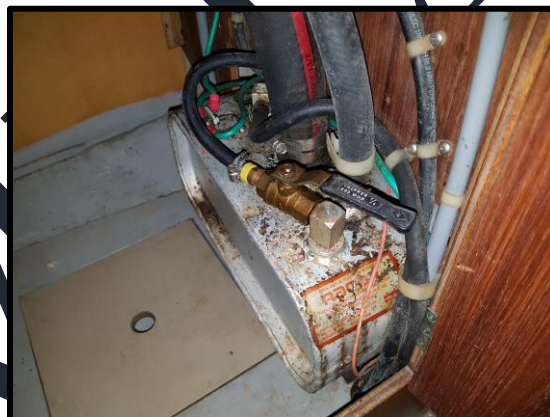
**See Item 5**

**Type and Condition of Fuel Lines / Filters / Fill Hoses:** Neoprene fuel lines are in serviceable condition but not USCG Type A1. Fuel filter / water separator is installed and appears to be in serviceable condition.

5- Transport Canada TP1332 recommends that all fuel supply line in the engine compartment be of USCG Type A1 or A15 neoprene.

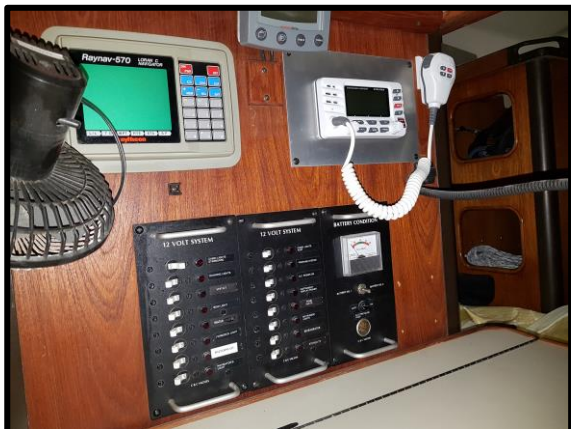
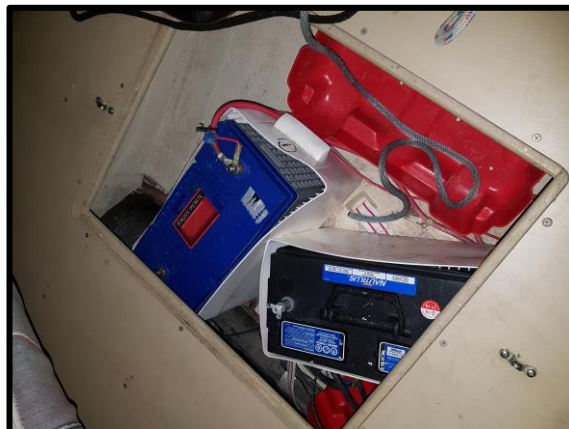
**See Item 6**

**Installation:** Are installed in approved housings, not secure. Positive posts are not insulated and are secured by wing nuts.

6- **ABYC E10** recommends that batteries be installed and secured to prevent the movement of batteries by no more than 1" (25mm) in any direction. The cables should not be secured by wing nuts and the positive posts should be covered with a dielectric material.
