# DS Marine Surveys

## Condition and Valuation Survey Report #

**Builder:** C&C

**Model/Type:** 37R

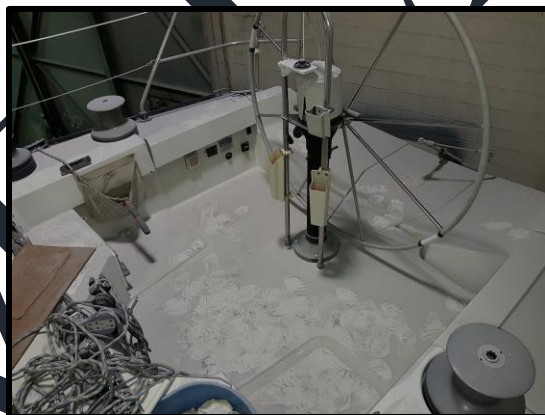
**Scuppers:** 2 drains are located at the aft side decks which drain through flexible hoses into above waterline through hull fittings. All components are in functional visual condition and the hoses appear clear.

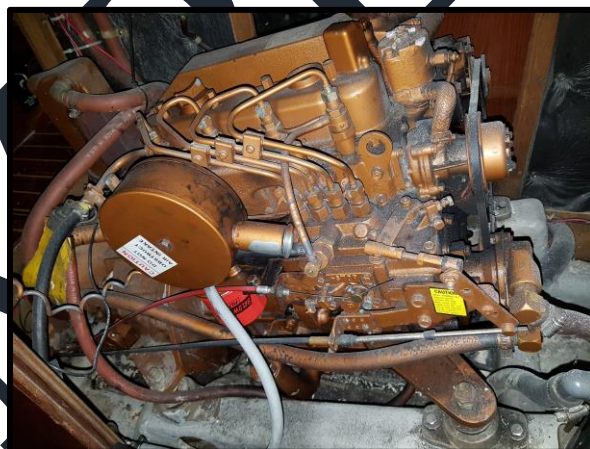
**Exhaust System:** Water cooled, cast iron manifold with integral riser is in apparently functional condition showing no external corrosion. Type approved neoprene hose is in serviceable condition and double clamped at all connections. Water lift muffler is fitted. Back flow protection appears adequate. Exhaust exits at aft hull.

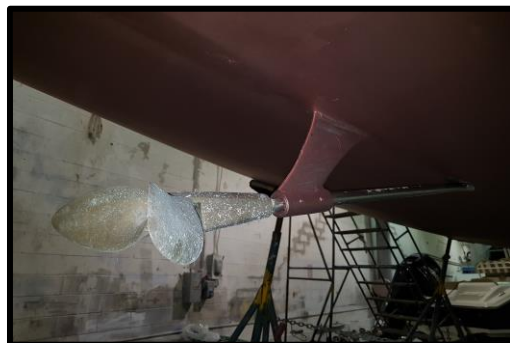
**Shafting:** 1" dia. stainless steel prop shaft was found to be in serviceable condition and true. Water lubricated shaft bearing in strut deadwood fitting. Shows little play and the strut is secure to the hull. Shaft seal (*appears new*) is connected to the stern tube with double clamped re-reinforced neoprene hose which is in serviceable visual condition.

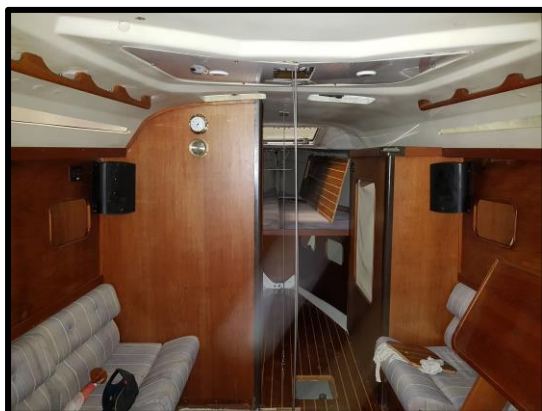
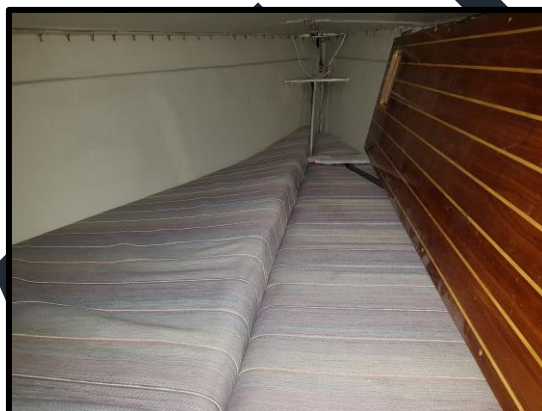
**Bulkheads and Joinery:** Construction is teak and veneered teak plywood. Good condition.

*A repair was noted on the lower port side of the main cabin bulkhead. Appears sound.*

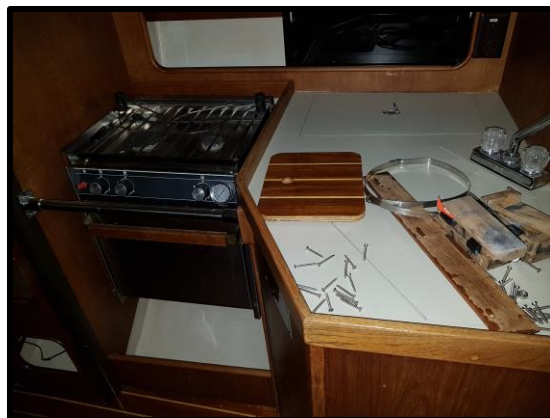
**Refrigeration:** 12 VDC refrigeration unit is installed in the galley ice box. Not tested.

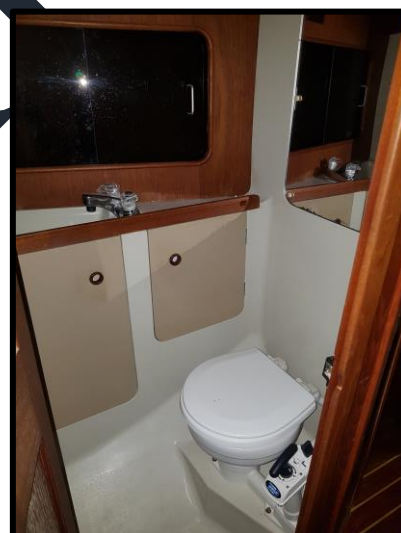
**Tankage and Hoses:** Plastic tank. Piping is by vinyl hoses secured by stainless steel clamps. All were inspected where accessible and found to be in serviceable condition.
